**Flood Control Project Maintenance
Levee Inspections**

Fall 2019 Levee Maintenance Deficiency Summary Report

Sacramento River Basin

**Flood Control Project Maintenance
Levee Inspections****LMA District Cover Sheet****Fall 2019 Levee Inspection Results****Reclamation District No. 0003 Grand Island**

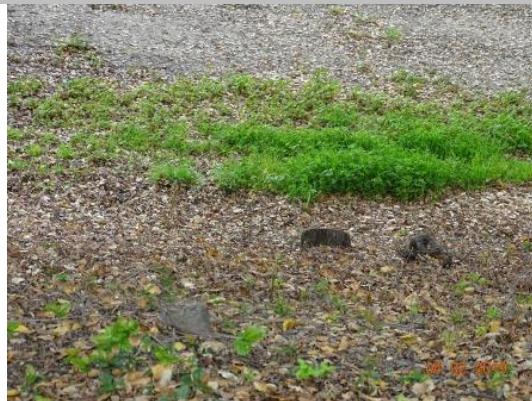
Photo 1 of 1 : FA_2019_RD0003_25_113_20190826_00081.jpg

LM Start	17.29	Rating **	N	Issue No.	113
LM End	17.29	Issue Type +	Ma	Location *	LS
Category	Earthen Levee			GPS Latitude/Longitude	
				Start	End
Item	Trim / Thin Trees			38.303558 °	38.303558 °
				-121.573380 °	-121.573380 °
DWR ID	DWR_RD0003_02_s_2019_113				
Comment Code					
T5 : Tree stumps.					
Inspector Comment					
There is a tree stump about 6" at bottom of the levee slope.

View looking downslope at tree stumps on the landside (Spring 2019).

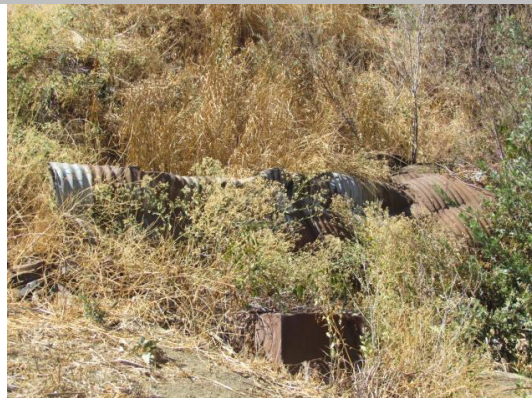
Photo 1 of 1 : FA_2019_RD0003_610_1_20190826_00001.jpg

LM Start	0.02	Rating **	M	Issue No.	1
LM End	0.02	Issue Type +	En	Location *	WS
Category	Earthen Levee			GPS Latitude/Longitude	
				Start	End
Item	Encroachments			38.182059 °	38.182059 °
				-121.653608 °	-121.653608 °
DWR ID	DWR_RD0003_03_f_2015_1				
Comment Code					
GA : Garbage					
Inspector Comment					
There is a discarded pipe on waterward slope.

Looking at discarded pipe on waterward slope.

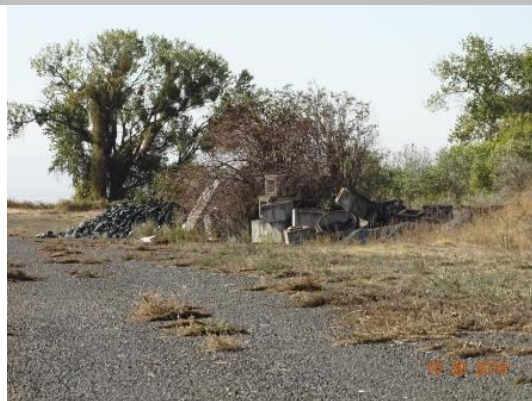
Photo 1 of 1 : FA_2019_RD0003_610_6_20191031_00002.jpg

LM Start	0.25	Rating **	A/W	Issue No.	6
LM End	0.29	Issue Type +	En	Location *	WS
Category	Earthen Levee			GPS Latitude/Longitude	
				Start	End
Item	Encroachments			38.178635 °	38.178037 °
				-121.653695 °	-121.653715 °
DWR ID	DWR_RD0003_03_s_2013_6				
Comment Code					
MA : Material					
Inspector Comment					
Stockpile of concrete rubble and a sandpile on waterside slope for immediate access to some flood fight materials.

View of material stockpile that District uses for flood fight material (Fall 2019).
